**DESCRIPTION OF SCENE**

VIKING LANDER MOSAICS

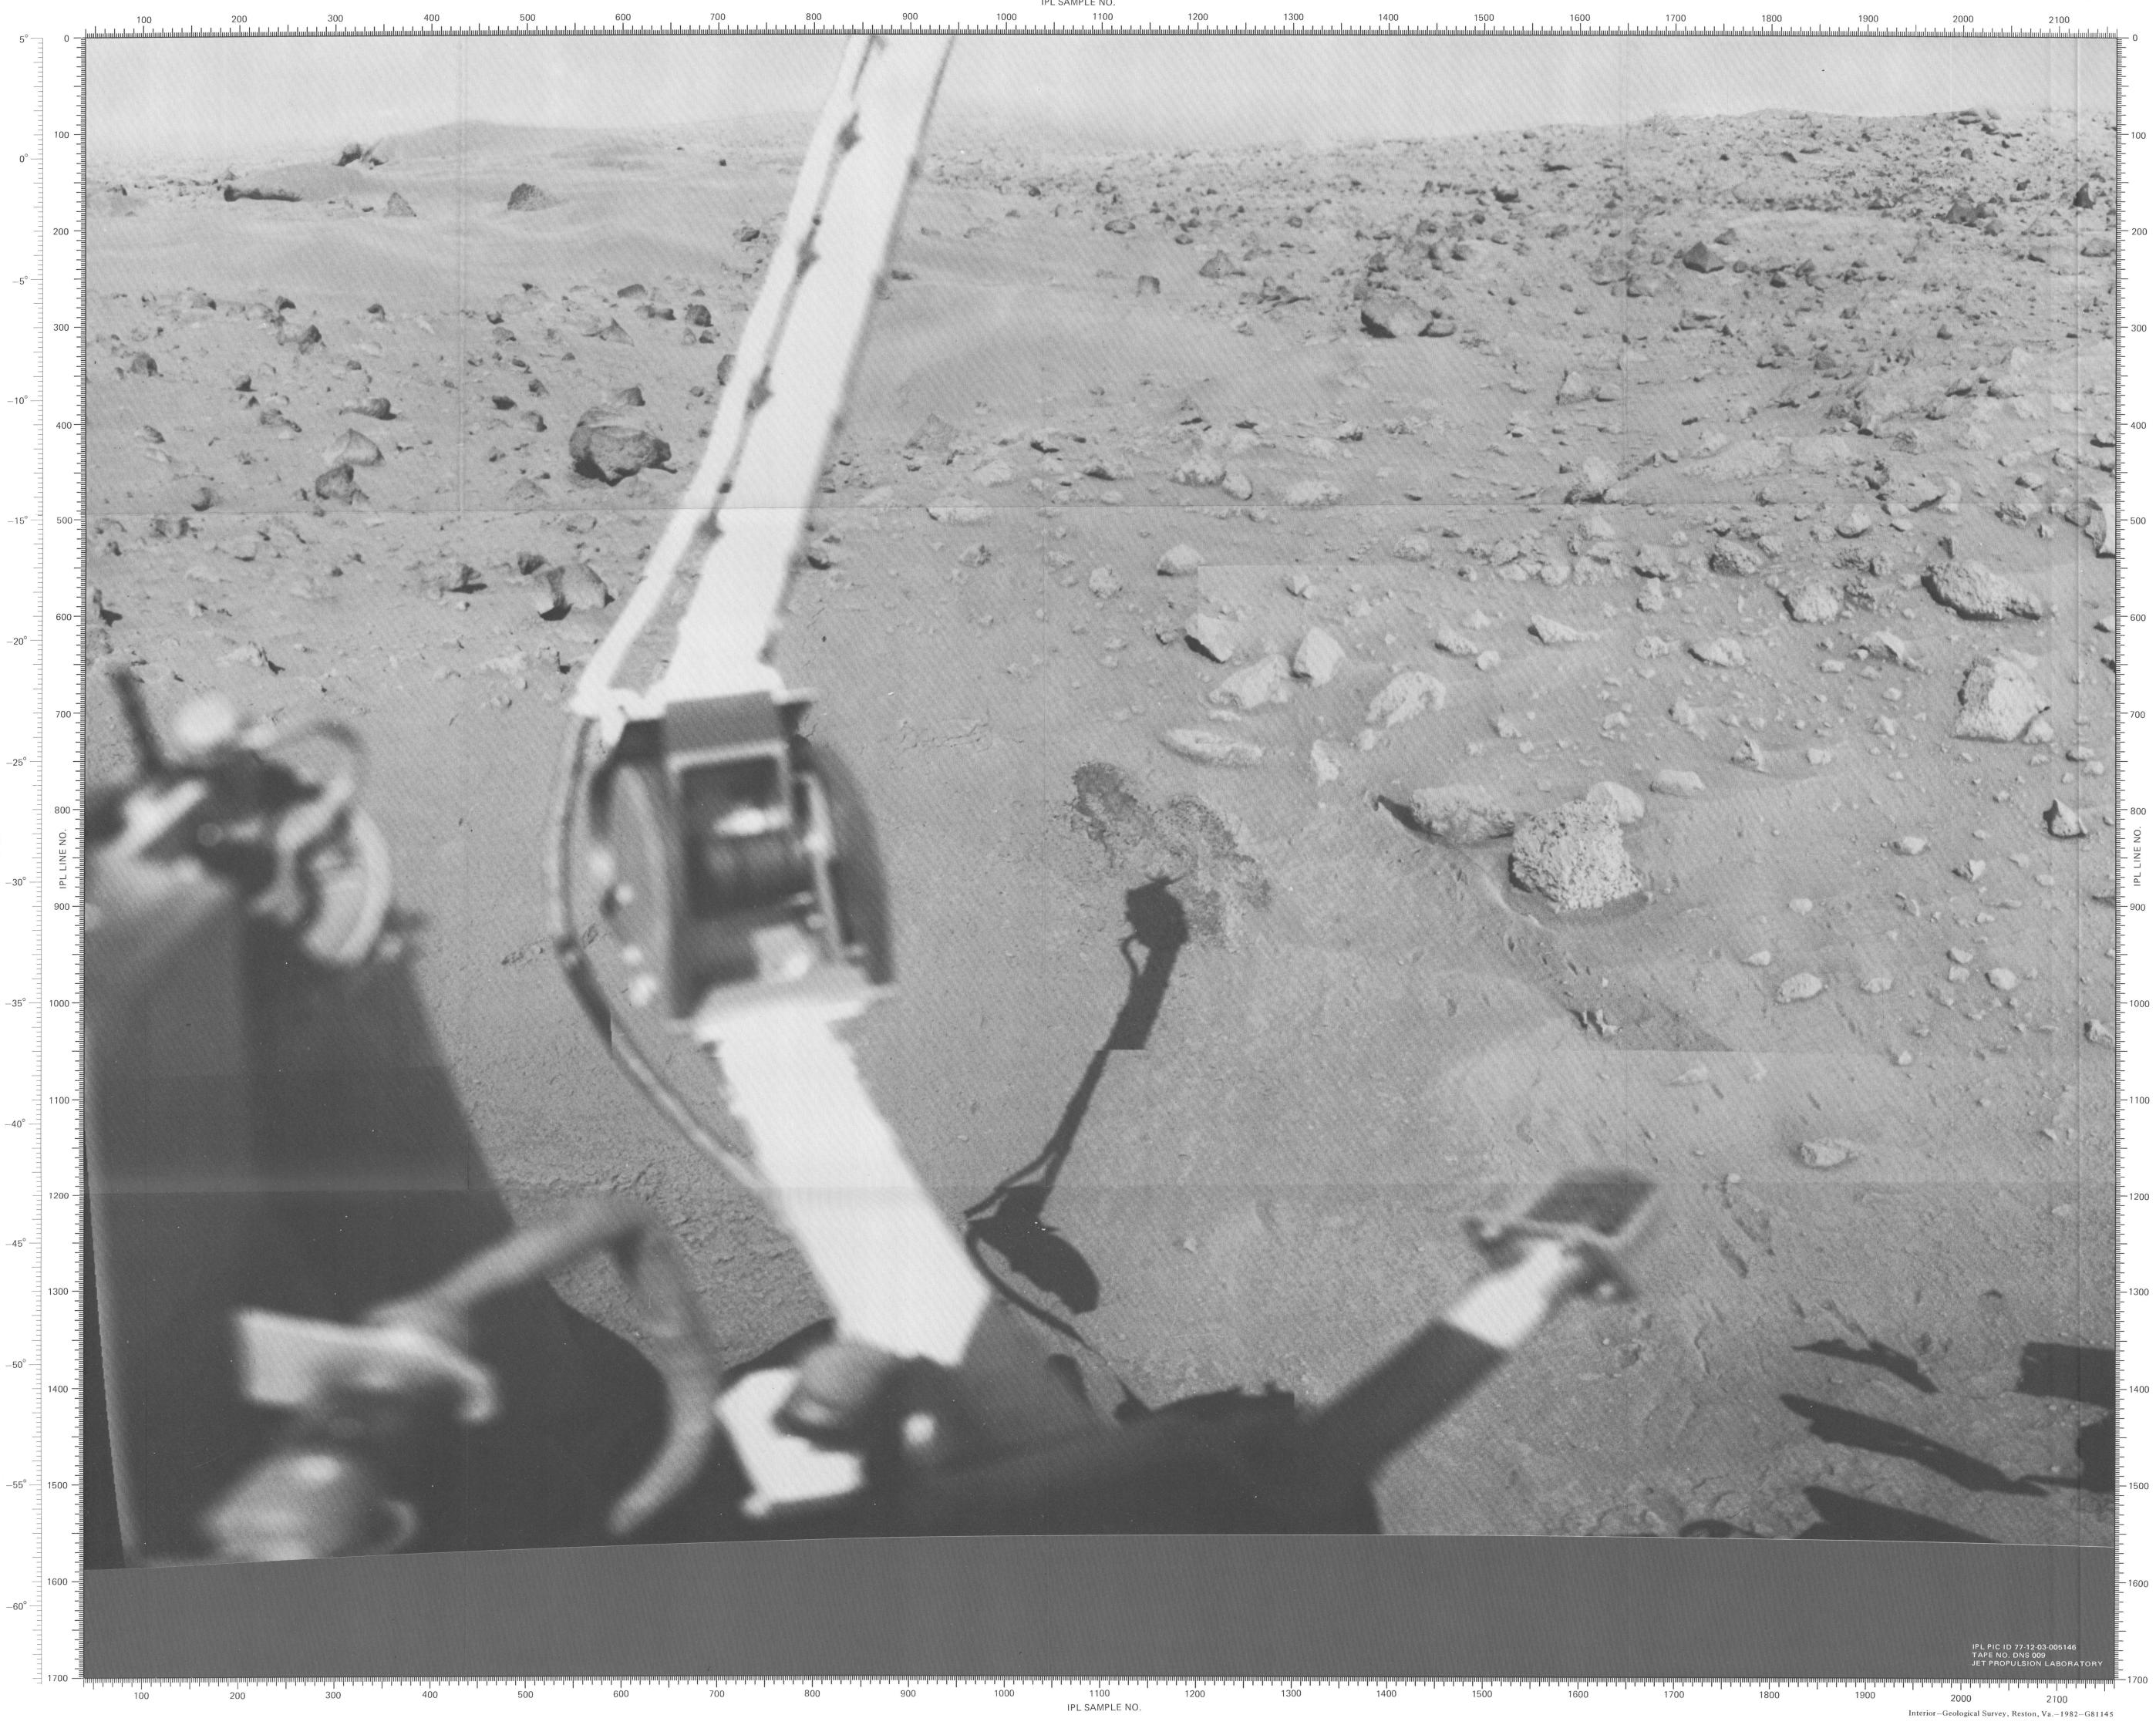
the rocks that litter the surface, and is banked up behind many of them to form "wind tails" (line 460, sample 340). The rocky rim of Crater C, about 150 m in diameter, forms the horizon at the right, about 80 m from the lander. The rounded crest of a wrinkle ridge known as "white mesa" is also prominent on the horizon (line 100, sample 1000) about 1.2 km from the lander. Footpad 2 of the lander is buried about 16 cm in the dusty material of a drift. Its outline is visible at the lower left (line 1300, sample 750). The surface sampler dug a trench (line 800, sampler 1100) in the drift to obtain soil samples for analysis by instruments on board the lander. As the surface sampler instrument retracted with a sample in its scoop, some of the material spilled on the surface of the drift and formed a track of little pits (line 1050, sample 1200). Other pits and tracks formed by the impact of particles blown off the surface by the rocket engines during landing can be seen at the bottom right of the scene (line 1340, sample 1880). Jarring of the surface when the lander touched down formed cracks in several drifts (line 1420, sample 1700). Some of the rocks littering the surface appear to be fine grained (line 630, sample 1465). However, most are coarse grained (line 700, sample 2050), and may contain coarse crystals or, like many lunar rocks, they may be brecciated. Many rocks have pits and holes that may be vesicles, indicating a volcanic origin. Parts of the lander that are visible in the mosaic are the mounting structure (line 900, sample 50), stroke gauge (line 720, sample 90), and shock absorber (line 1040, sample 330) of leg 2. The tubular structure that crosses the center of the scene is the meteorology boom and its hinge (line 800, sample 700). A metal brush for cleaning the magnets on the surface sampler instrument is on the end of a short boom (line 1220, sample 1600).

East of the lander, the martian scene displays,

conspicuous drifts of fine-grained material (line

200, sample 580). The drifts are 10 to 20 m from

the lander. Some of their wind-sculptured surfaces

which suggest cyclic deposition. The fine-grained

material also blankets much of the area between

expose internal layering (line 300, sample 1000),

The cameras on the Viking Lander acquire data by sampling in equal increments of elevation and azimuth angle. In the accompanying mosaic, 8 mm subtends a 1° horizontal or vertical angle, regardless of the place of measurement within the panorama. If the martian surface were flat, one pixel (0.04° on the surface would be 1 mm wide at -60° camera elevation and 2 m wide at the horizon 3 km away. Characteristically for this type of imaging system, most straight lines

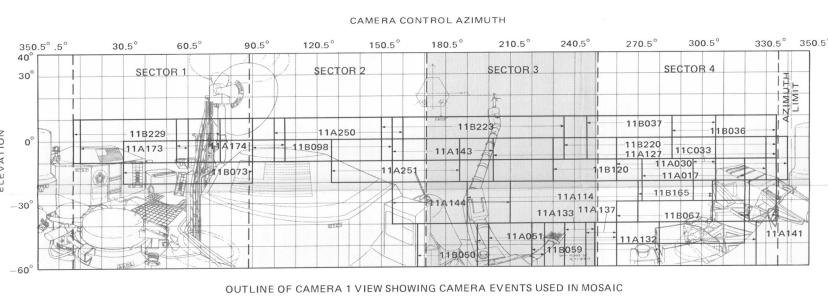
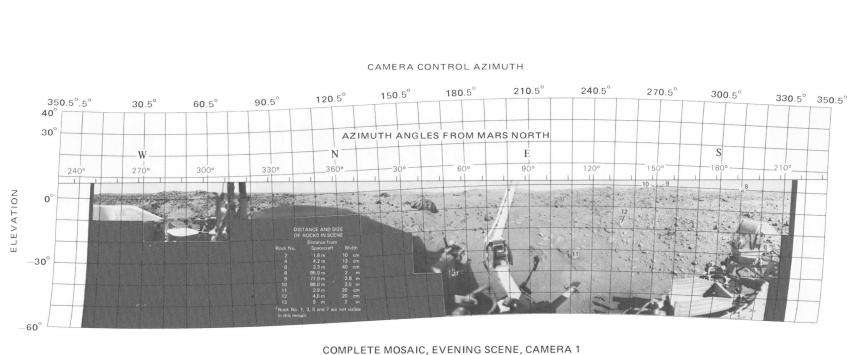
VERTICAL VIEW SHOWING VIKING LANDER 1 ORIENTATION

(Corrected for tilt)

Grid is in spacecraft coordinates
